Herring Farmstead

Johnsville, Maryland

Survey No. F-8-117
Herring Farmstead
Johnsville, Maryland
Frederick County

**Maryland Historical Trust
State Historic Sites Inventory Form**

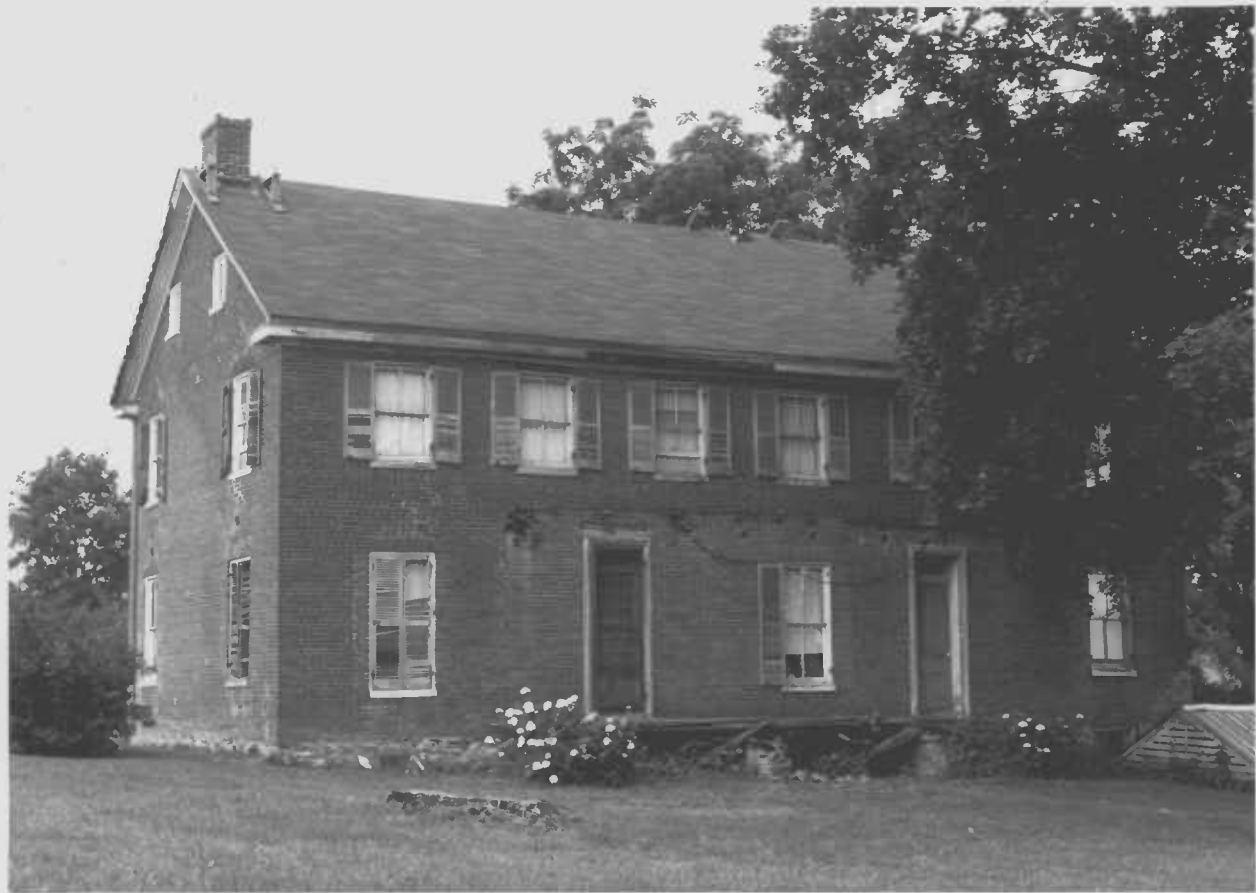
1/7

North elevation

The dwelling house is a two-story rectangular brick building with a gable roof running east-west. The principal elevation is the north side, which is 5-course American bond, as are all the elevations. The north elevation has an irregular bay arrangement, indicating possibly two or more periods of buildings, but little exterior evidence confirms this other than a possible removed center chimney. The first story has five bays and the second story has six. Two entrances with bolection molding surrounds, commonly used in 18th century buildings, alternate with windows with 2/2 sash. The upper story windows have some louvered shutters which are deteriorated. The window openings on the first story have gauged brick arches and the second story has flat header arches. The doors are four panel types with round arches formed by moldings in the upper section, a typical pattern of the middle third of the 19th century and later. The openings have plain wood lintels and single-light transoms. Evidence on the brick surface indicates a shed one-story porch has been recently removed. The deck is greatly deteriorated. The stone foundation is exposed on the north and west elevations. The roof is composition and has a box cornice. The side elevations on the east and west have interior brick chimneys flanked by two window bays. The south elevation is even more complex than the north elevation. It has three entrances and six bays with an extra window inserted between the three-bay halves of the elevation. A cellar entrance is located below the first floor southwest corner bay. A one-story porch was also removed from this elevation and the wood deck appears to be new. At the time of survey, a scaffold for roof repair was in place in the center of the elevation. A slight variation in the roofline suggests an interior chimney was removed, a possible indication of the original form being a three-bay house later expanded. The first story openings have gauged arches and the second story has header flat arches. The doors have glazed upper panels ~~on both the first and second stories~~ above two base panels. Two window openings on both the first and second stories have been filled in with brick.

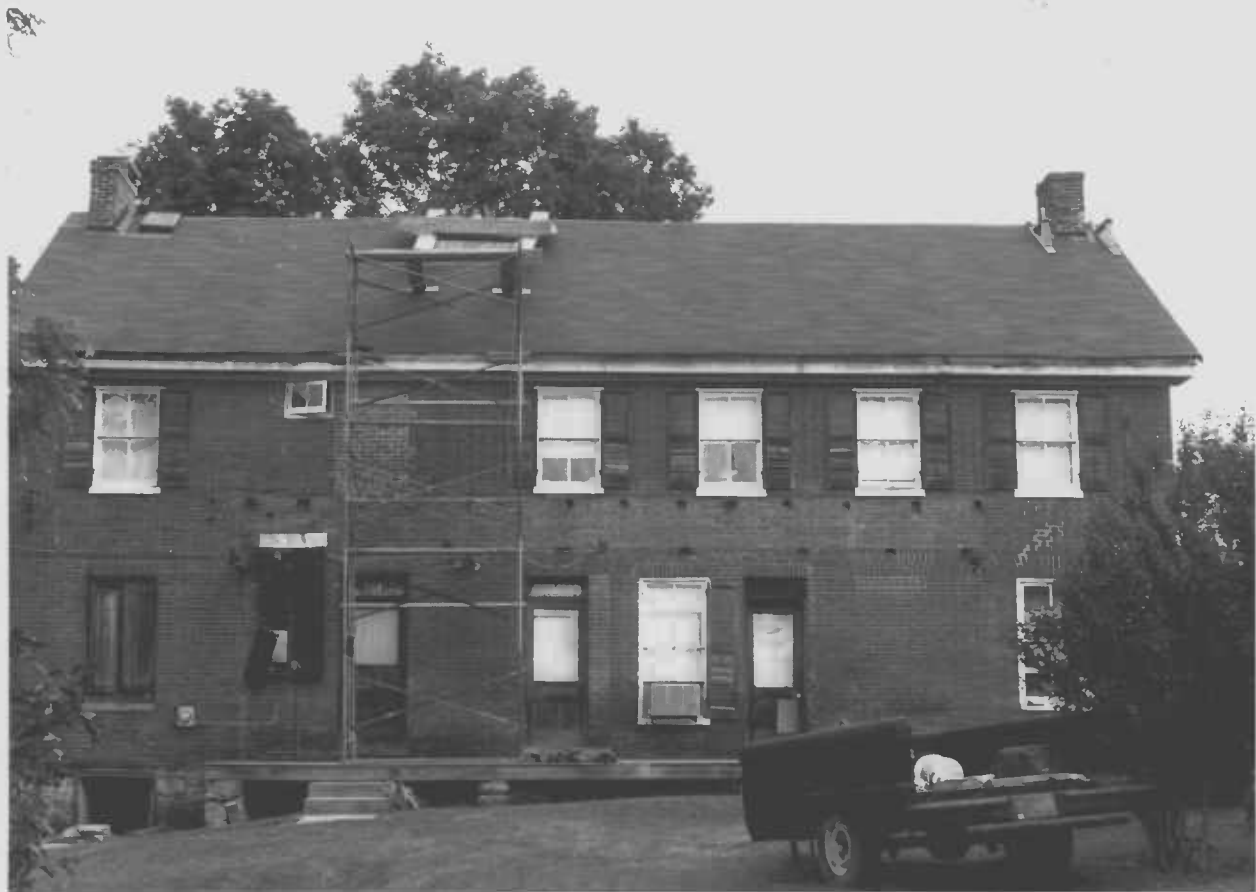
2/7

South elevation

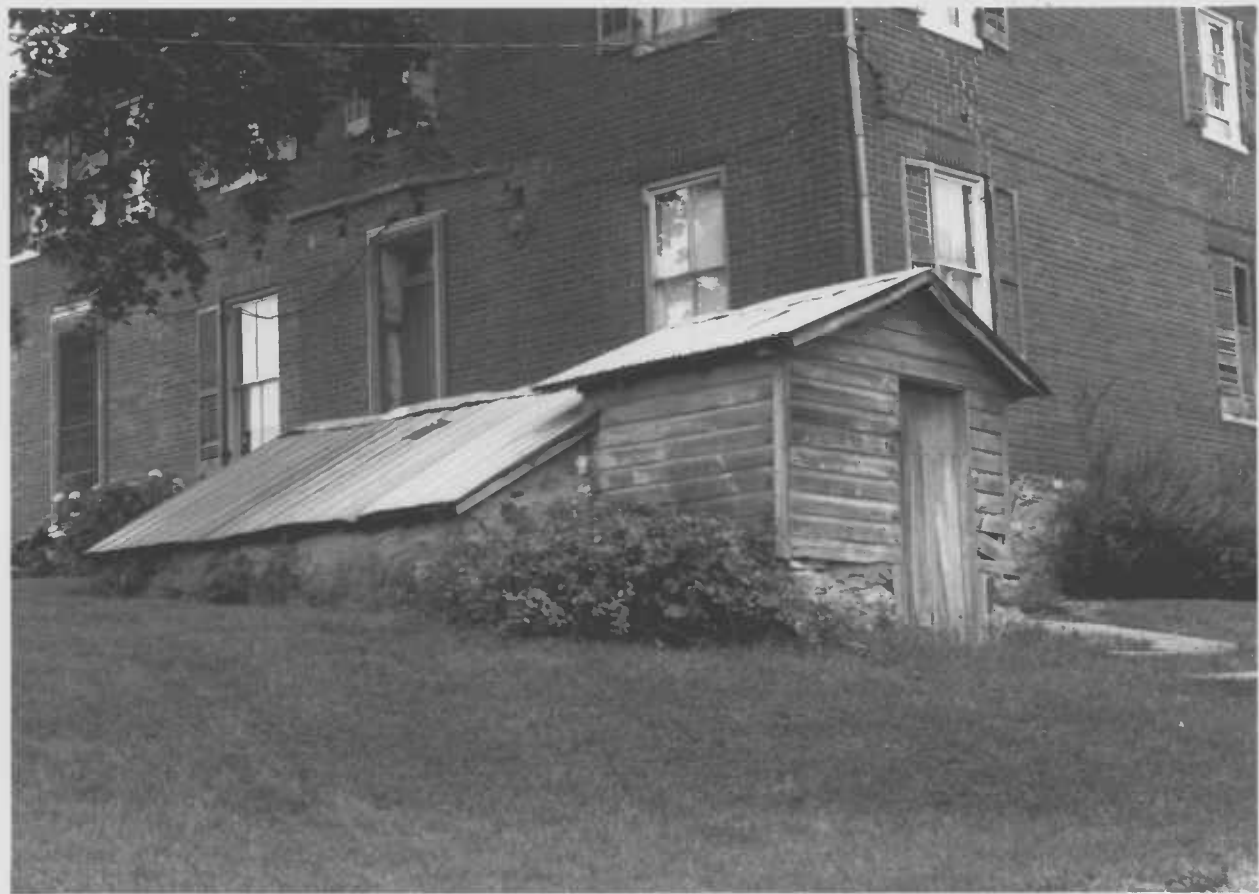
3/7

Ice house/springhouse, northwest corner
view

Springhouse: This is a stone structure set into the ground immediately north of the northwest corner of the house. It has a projecting doorway with a gable roof on the exposed west elevation. This section has clapboard siding and a vertical board door. Both sections have replacement standing seam metal roofs. The form of the springhouse is more typical of an icehouse. Confirmation of its original use may be made by access to the interior, which was not available at the time of survey. The springhouse is possibly dated in the second quarter of the 19th century due to its form and materials.

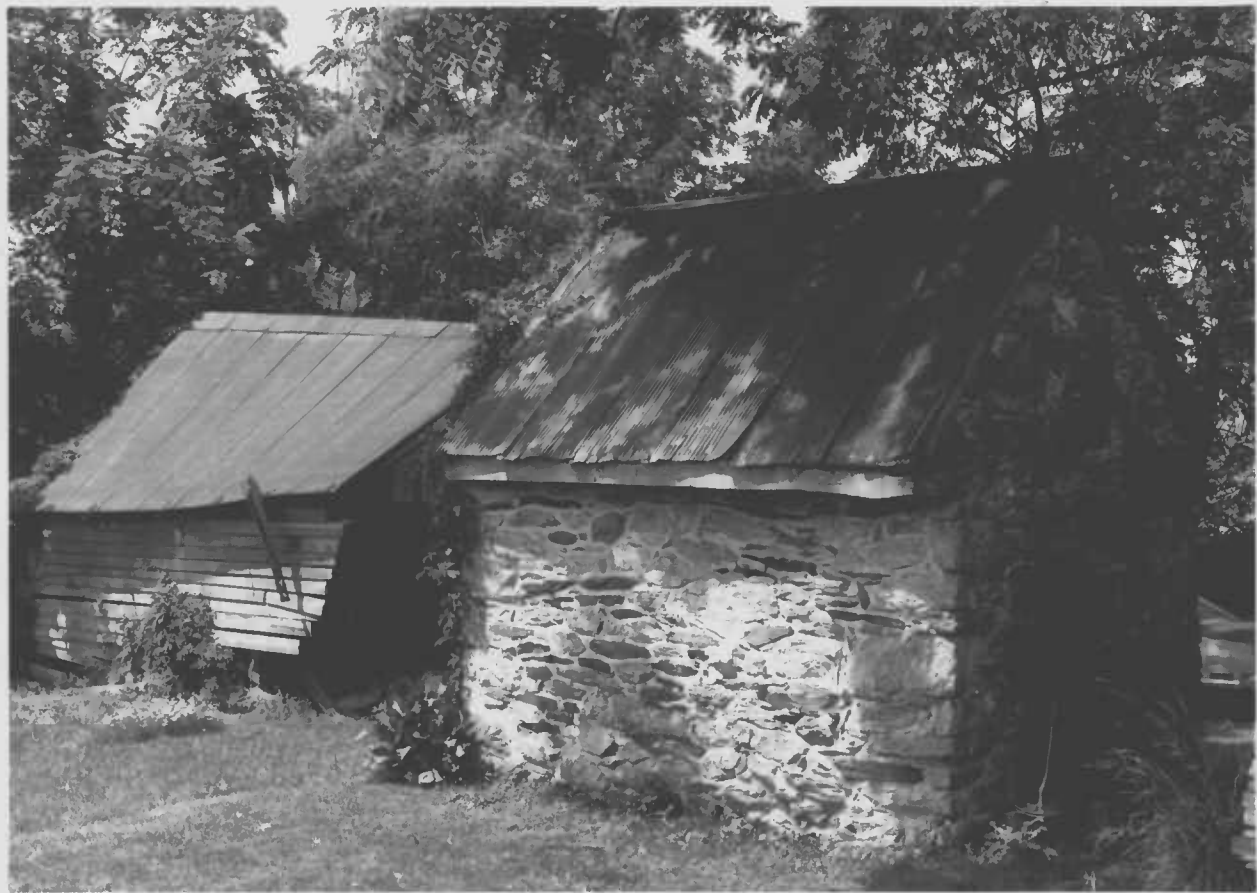
4/7

Smokehouse and shed, east elevation

Deteriorated shed: The shed is located about 10 yards south of the southwest corner of the house. It has a shed roof of corrugated metal and its rear wall is partially collapsed. The shed configuration suggests a chicken house, but it may have had other domestic uses. It is located immediately in front of the door to the smokehouse, suggesting it was a late 19th century addition to the domestic group.

Smokehouse: This is a stone one-story rectangular building with a single door on the north. The door has been cut down to half-size and the building is now used for storage. The rubble stone exterior has been repaired with concrete at the southwest corner. The gable roof is corrugated metal and a vertical vent is located just below the south gable peak. The smokehouse may be contemporary with the springhouse, from the second quarter of the 19th century.

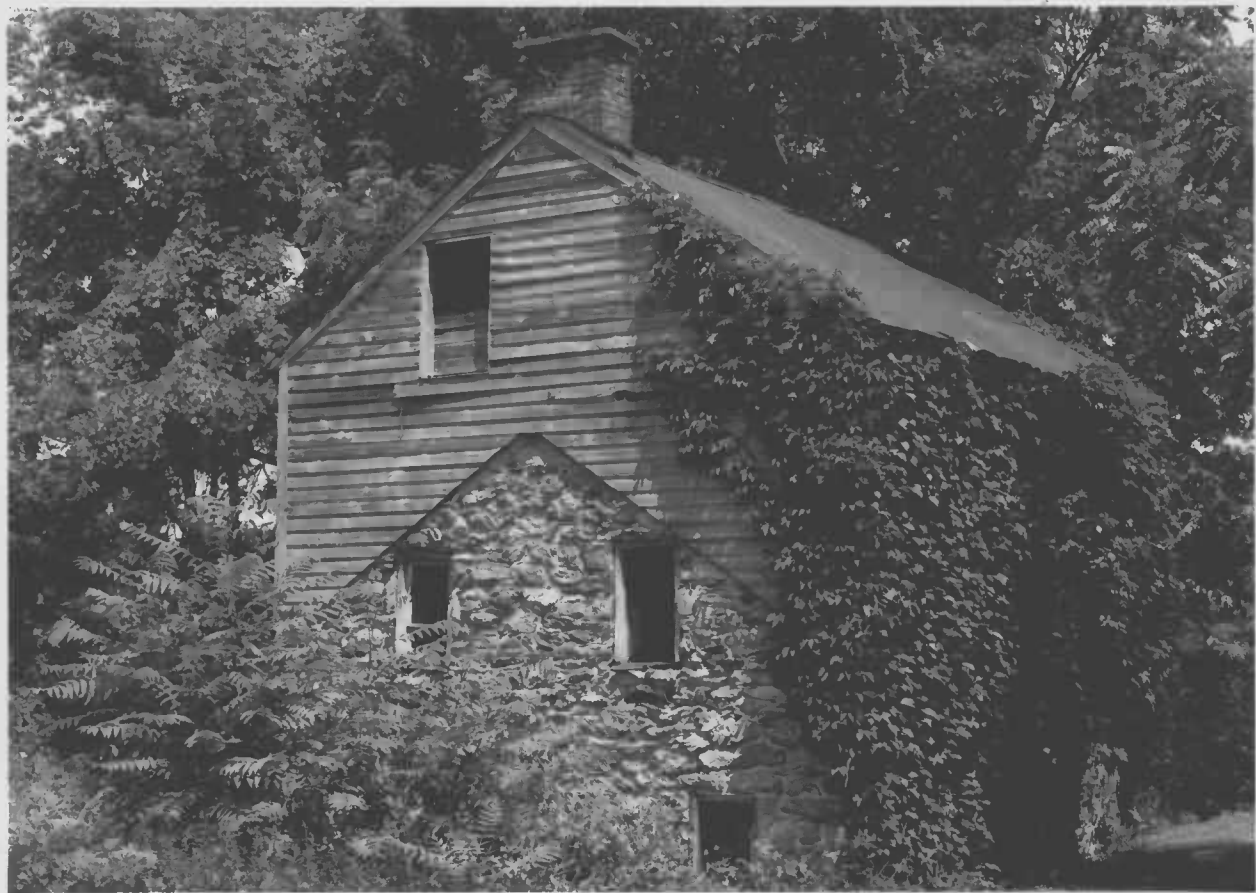
5/7

Summer kitchen / "slave quarters", south
elevation

Summer kitchen: This is a two-story rectangular building with a stone lower level exposed on the west elevation and a frame upper level with a gable roof of corrugated metal. A ghost of a lower gable-roofed extension or other section is visible on the south elevation. A corrugated metal shed canopy is attached to the west elevation over the lower level. On this elevation, the stone section has two doorways and three alternating window openings. The sash is deteriorated, but is mostly 6/6. The doors are vertical flush boards. The interior is filled with debris, but a brick interior chimney is visible on the south wall. A chimney rises above the roof at the south gable end. The upper section is deteriorated, revealing under the clapboard siding a plaster and lath interior wall. A single four-panel door is located in the center of the north elevation, but the access stairway or porch is missing. The dating of the summer kitchen is difficult, but the stone section may be older than the frame upper portion, possibly built about 1830. The plaster and lath wall indicates the second quarter of the 19th century also, but further research on the building and its interior must be done to pinpoint a time of construction. Its use as possible slave quarters may also be confirmed by interior documentation and further research on the historical owners of the property. A second theory on its function may relate to the nearby saw and grist mill sites on the creek to the west of the farmstead. No sites have been confirmed in the area, but their proximity as shown on the 1873 Titus Atlas Map must be considered as having some possible connection with the Herring Farmstead, although no mention of these buildings is found in the land records regarding the property.

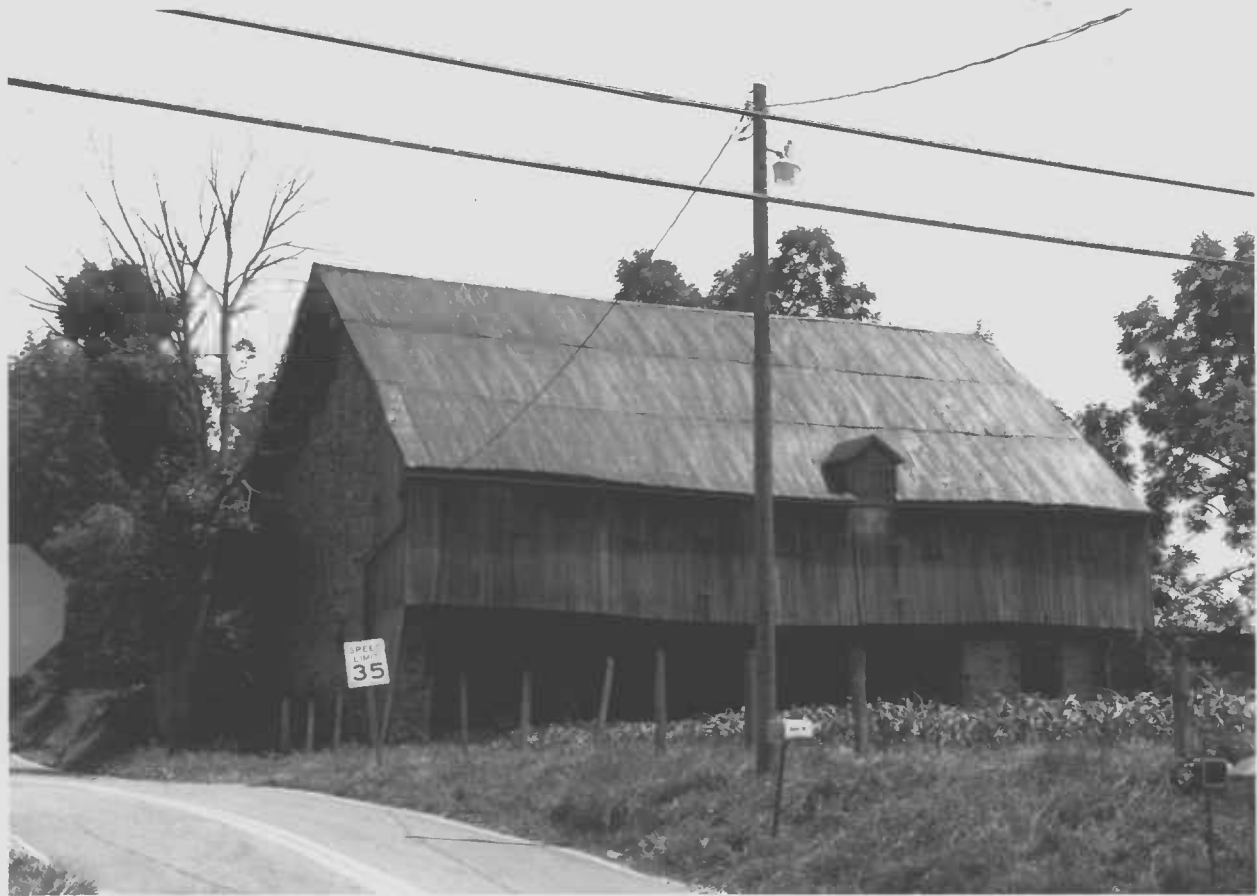
6/7

Bont barn, south elevation

Stone barn: This building was possibly erected in the first quarter of the 19th century and has a rubble stone structure with a frame forebay on the south elevation. A loading door in a single dormer is located off-center in the standing seam tin roof on the south elevation. The frame section has beaded vertical siding. The lower level of the barn has not been enclosed and reveals the remnants of at least two feeding aisles, several mangers and other wood elements. Some of the supporting beams and timbers of the barn structure appear to have been replaced or added to give further strength. On the east and west elevations of the stone section are vertical vent slit openings. The doors to the barn floor are tongue and groove sliding doors, apparently replacements of the last quarter of the 19th century.

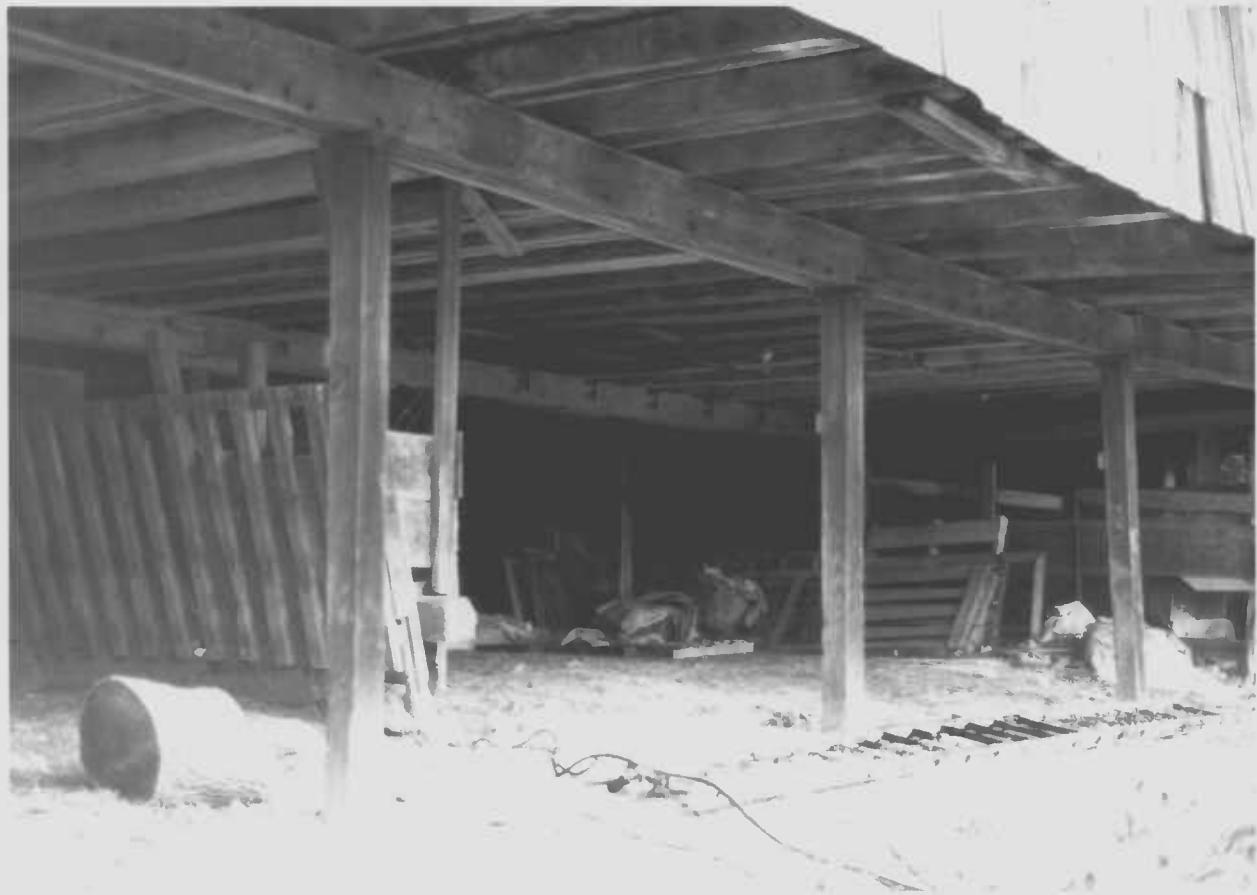
7/7

Bank barn, forebay detail
